**SUBJECT: START 3, EPA Region 8, Contract No. EP-W-05-050, TDD No. 1008-13  
Trip Report-Revision 1-for August 2011 Sampling and Field Activities,  
Upper Animas Mining District, Silverton, San Juan County, Colorado**

## **APPENDIX A**

**Photo Log  
Cement Creek  
San Juan County, Colorado  
August 2011**

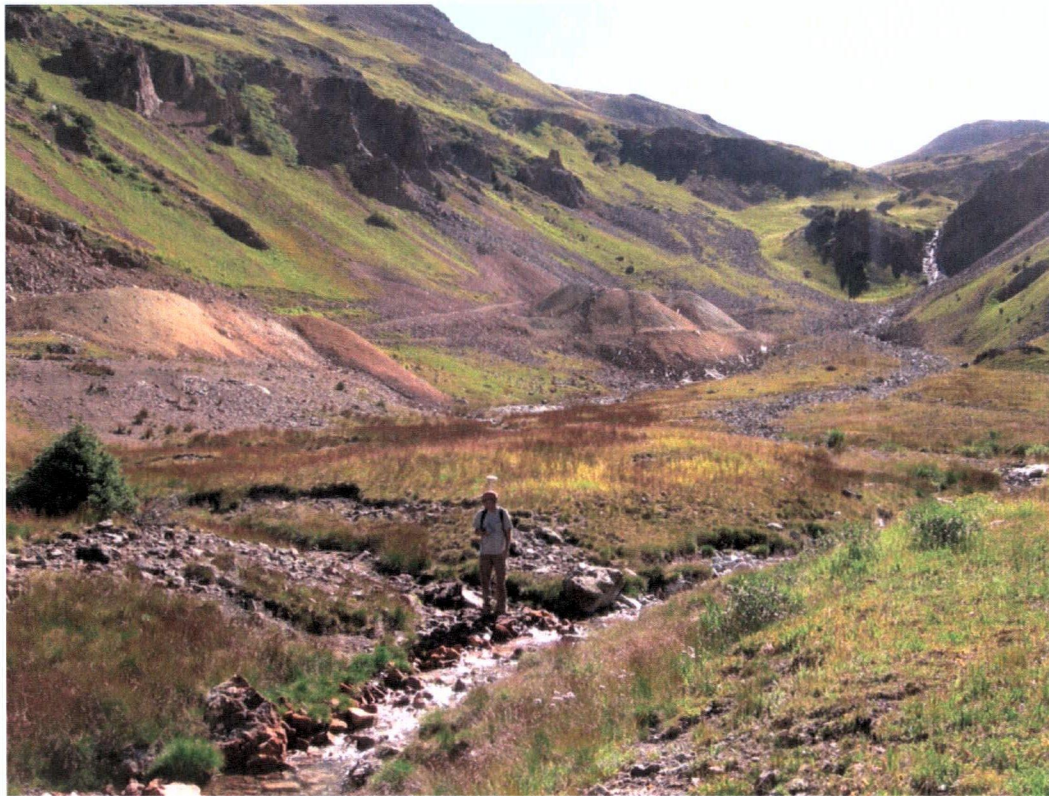
**PHOTO 2**

View to the east of the PPE from the Grand Mogul Mine into Cement Creek. Note iron staining of rocks in Cement Creek downstream of flow from Grand Mogul Mine. J. Miller of START at PPE collecting GPS location data.

- **Grand Mogul Mine:** The overland flow pathway for the Grand Mogul Mine begins at the western toe of the main mine waste pile and continues westward for approximately 300 feet until it enters Cement Creek (Appendix A, Photos 1 & 2). The actual point of exit from the ground is buried by the mine waste. The overland flow path as shown in Photo 1 is heavily stained with iron oxides (that begin to precipitate out of solution when the pH rises above 3.5) as compared to the stream course of Cement Creek on the left center of the photograph.

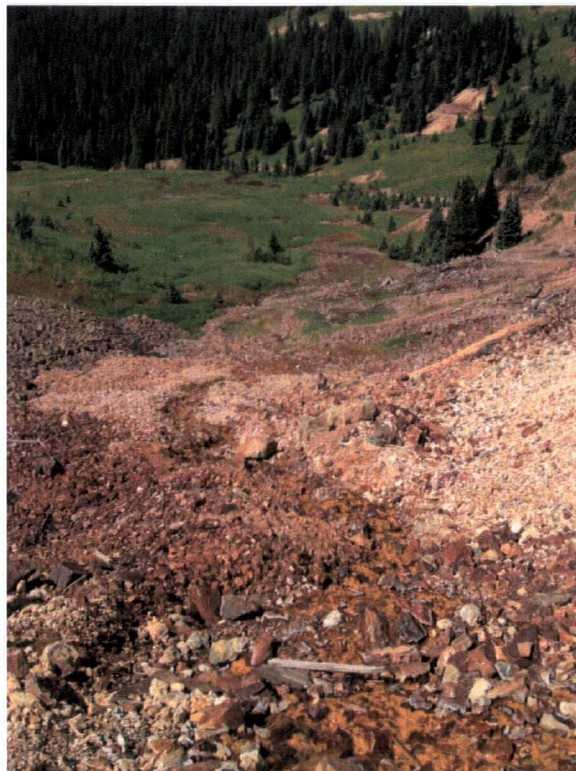
**PHOTO 3**

View to the southwest showing adit discharge water from the Mogul Mine flowing over mine waste rock into wetlands immediately downstream of Mogul Mine waste rock. Note the mix of scrap lumber and waste rock. Note staining of flow path into wetlands. Cement Creek is at the shallow part of the valley in the background.

- **Mogul Mine:** The discharge from the Mogul exits through an adit on the northeast side of the mine waste pile and flows across the top of the mine waste pile in a tarp lined ditch to the access road. Once the adit discharge crosses the road, it flows over a mixture of mine waste and mine trash into a series of wetlands below the mine (Appendix A, Photo 3). The overland flow pathway from the Mogul Mine covers approximately 1,200 feet before the PPE into Cement Creek. It can be observed that iron oxides are precipitating on the side of Cement Creek where discharge water from the Mogul Mine is entering Cement Creek (Appendix A, Photo 4).

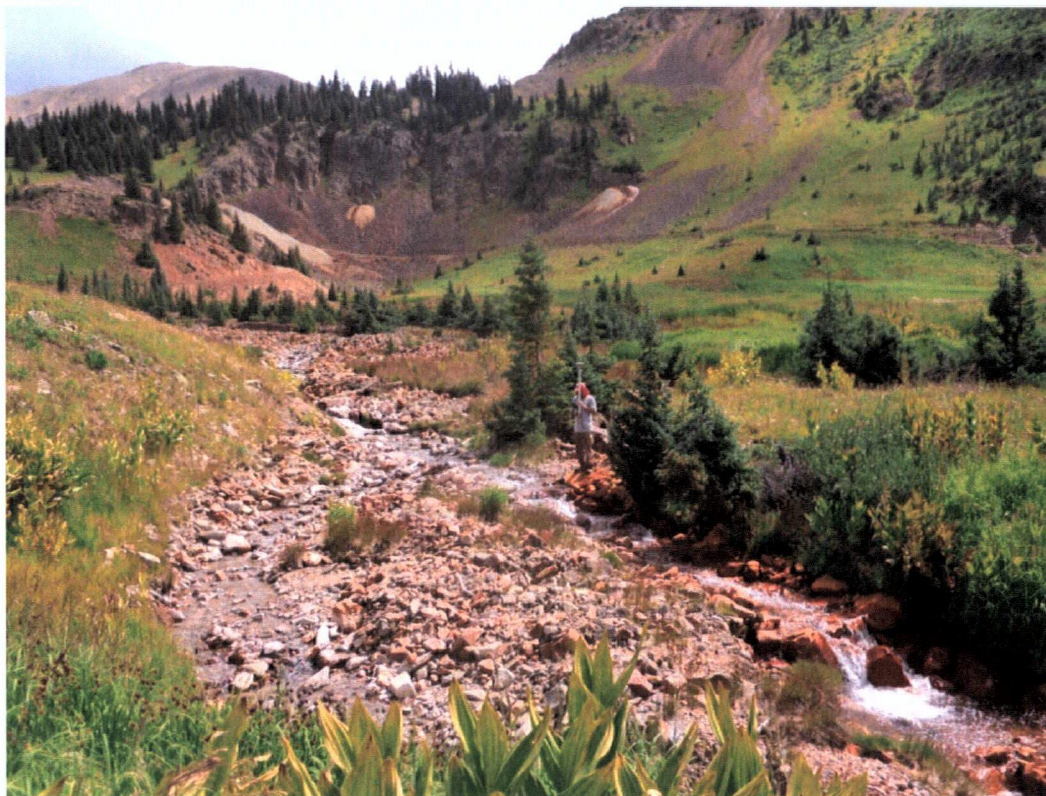
**PHOTO 4**

View to the east of the PPE of the discharge from the Mogul Mine into Cement Creek. The surface water pathway from the adit flows down to the road on the other side of the white patch of waste rock and through the wetlands. Note iron staining of Cement Creek on the inflow side of the creek from the PPE where J. Miller of START at PPE collecting GPS location data.

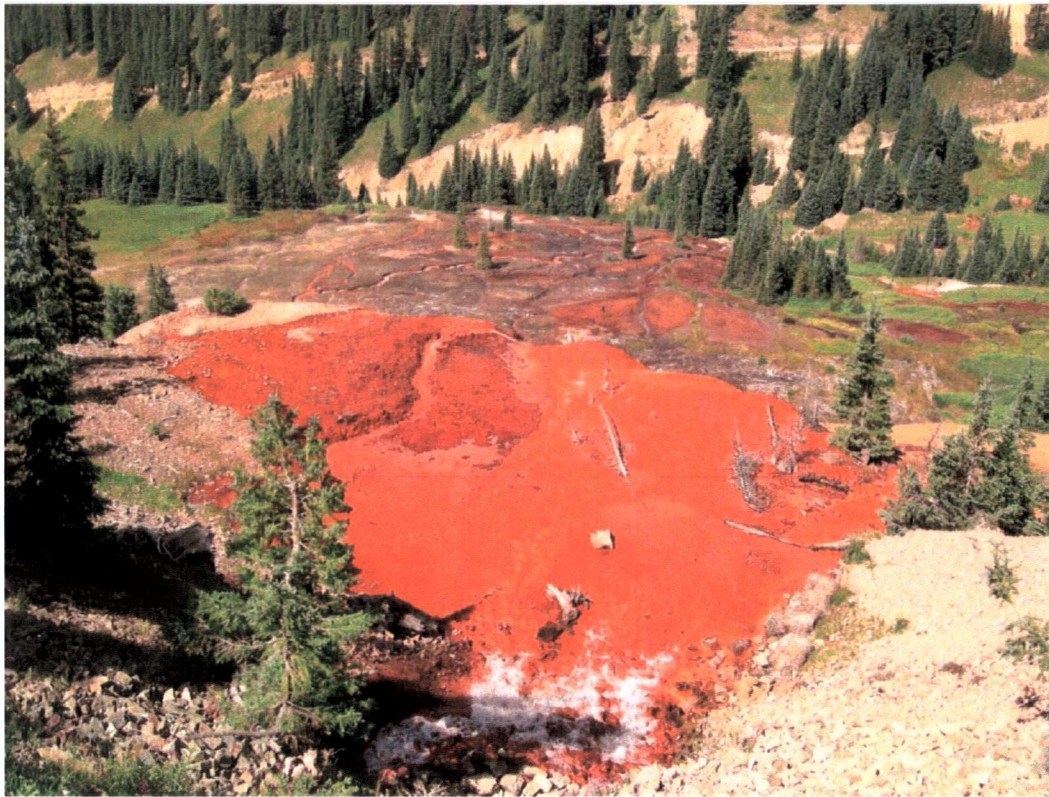
**PHOTO 5**

View to the west of the adit discharge from the Red and Bonita Mine. Note the strong color of iron oxide precipitation and the staining to Cement Creek along valley floor.

where it flows southward, then into a culvert directed westward under the road, and then directly westward across a barren iron oxide stained landscape to Cement Creek (Appendix A, Photo 5). The overland flow path after flowing under the road splits into two streams in the barren area before entering Cement Creek. The more upstream flow path was visually estimated to carry approximately 75 percent of the flow, and the smaller stream enters Cement Creek approximately 50 feet downstream of the larger stream. Photo 6 shows the upper dominant discharge point. Note the iron oxide staining in the Cement Creek streambed on the side of the PPE from the Red and Bonita Mine (Appendix A, Photo 6).

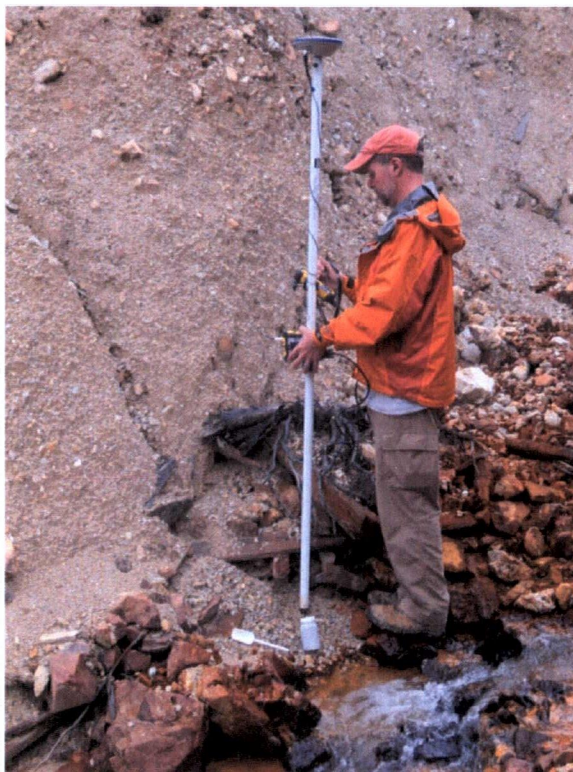
**PHOTO 7**

Gold King 7 Level Mine waste rock pile being eroded by the North Fork of Cement Creek. Note the erosion rills on the waste rock pile and undercutting by stream. J. Miller of START collects source sample UASO015 GPS coordinates.

Four samples of the mine waste pile at the Gold King 7 Level Mine were collected in accordance with the approved FSP. Sample UASO015 was collected from an area that was being actively eroded by the North Fork of Cement Creek, from material that appeared to be similar to the fine-grained limonite colored material (Appendix A, Photo 7). START personnel also collected source samples from each of the three types of mine waste material identified with the field XRF. One Matrix Spike/Matrix Spike Duplicate (MS/MSD) sample was collected with the sample from location UASO018.

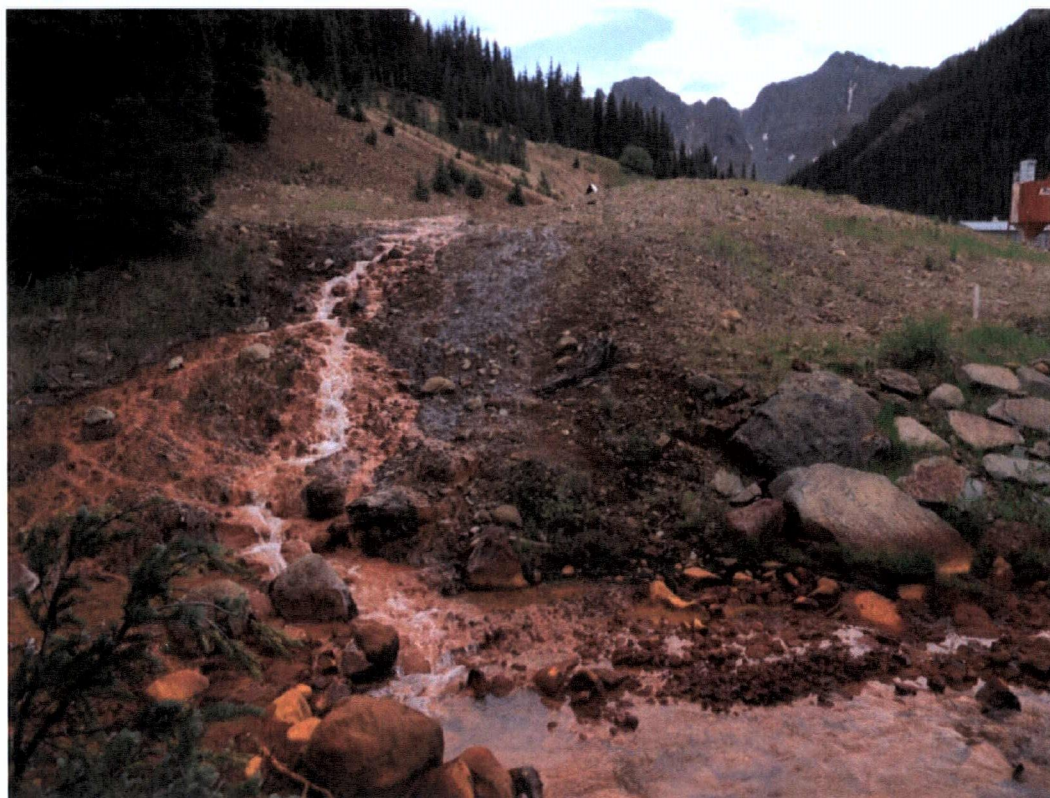
**PHOTO 10**

PPE from the American Tunnel outlet entering into Cement Creek. Note strong iron oxide staining downstream of PPE.

- **American Tunnel:** The discharge point for the American Tunnel is found just upstream of Gladstone where the discharge emerges from the diversion structure and flows approximately 200 feet westward to its PPE with Cement Creek. Strong iron oxide precipitate staining of the discharge and Cement Creek below the PPE was observed in August 2011 (Appendix A, Photo 10).

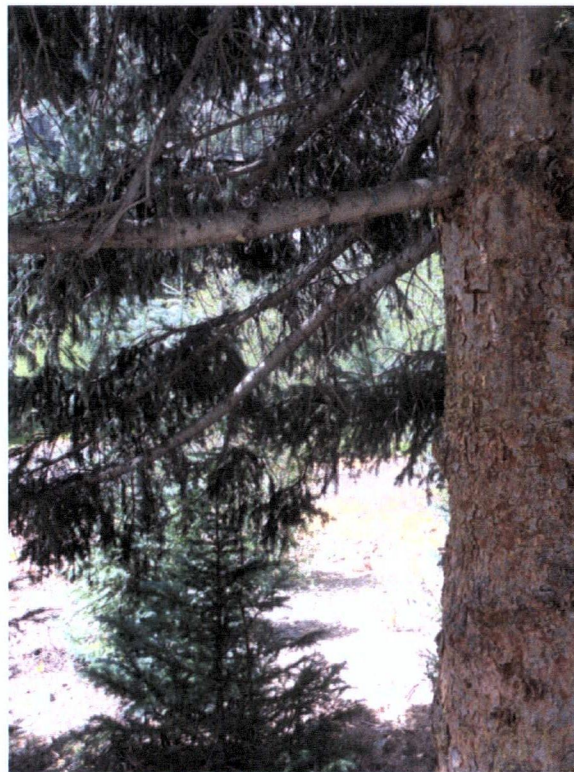
**PHOTO 12**

A fishing lure found imbedded on a tree limb along the banks of the Animas River in Elk Park. Lure is bright green on larger limb near the trunk.
